# Auger Electron Spectroscopy Study of Oxidation of a PdCr Alloy Used for High-Temperature Sensors

Darwin L. Boyd and Carlos Vargas-Aburto  
*Kent State University*  
*Kent, Ohio*

Mary V. Zeller  
*Lewis Research Center*  
*Cleveland, Ohio*

March 1993

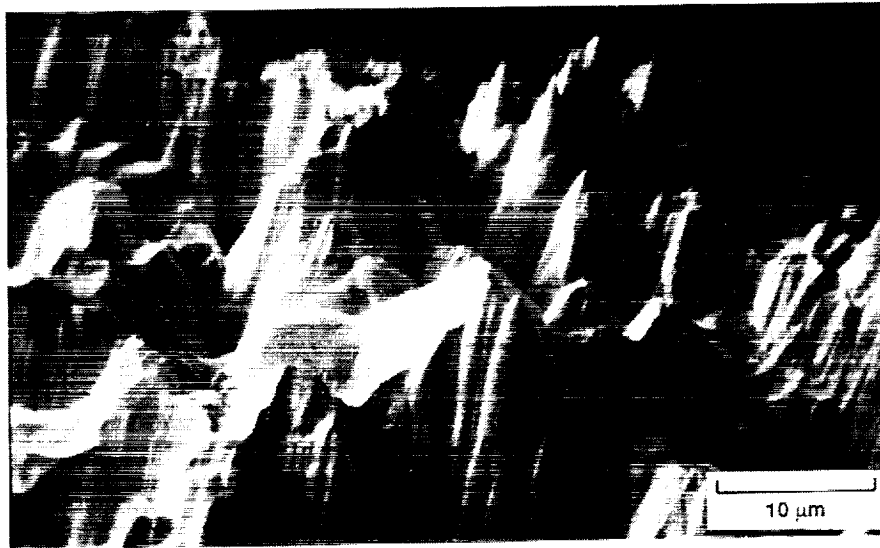
(a) Surface of unsputtered wire.

(b) Surface layers removed; oxidation visible along grain boundaries.

Figure 10.—Development of sputtering artifacts on PdCr wire annealed in air at 750 °C for 20 hr.

(c) Severe cone formation visible after 13 hr of sputtering.

Long sputter times were required to sputter through the relatively thick palladium and oxide layers on the air-annealed samples. As a result, sputtering artifacts, such as severe cone formation, occurred. The formation of these artifacts as sputtering progressed can be seen in figure 10, which shows SED images recorded at various sputter depths for a wire annealed in air at 750 °C for 20 hr. These sputtering artifacts contributed to the uncertainty in the exact location of the interfaces and to the scatter observed in figure 9. In addition, the interfaces were by no means planar or sharp. The combination of the sputtering artifacts and the broad, nonplanar interfaces could have resulted in significant variations in the thickness measurements. The relatively poor signal-to-noise ratio of the depth profiles, primarily due to instrumental problems (as shown in fig. 8), further contributed to the scatter observed in figure 9.
